AFWAL-TR-85-3073

**ENVIRONMENTAL STRESS
SCREENING TECHNOLOGY**

**Grumman Aerospace Corporation
Bethpage, NY 11714**

Final Report for Period September 1983 - March 1985

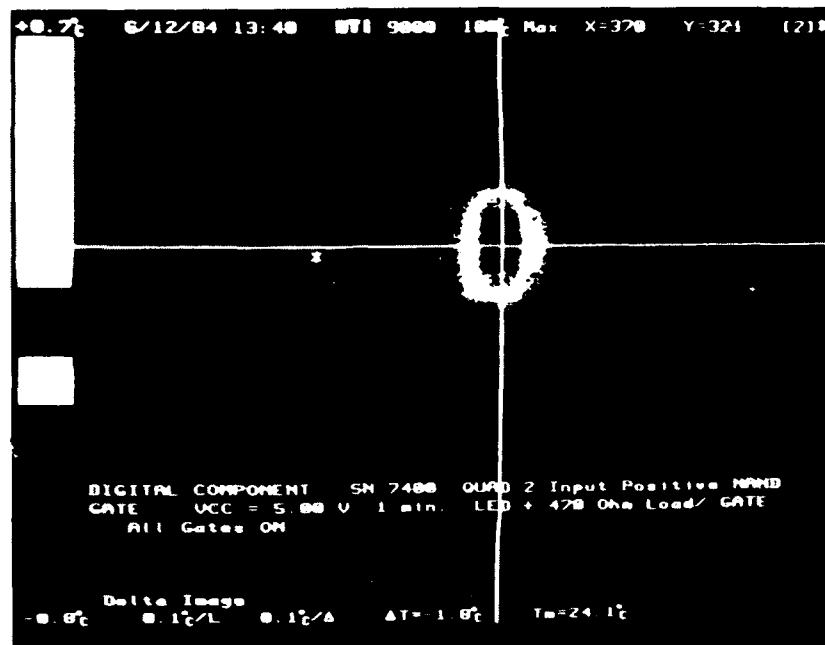
Figure 2 Typical delta mode, "no failure"

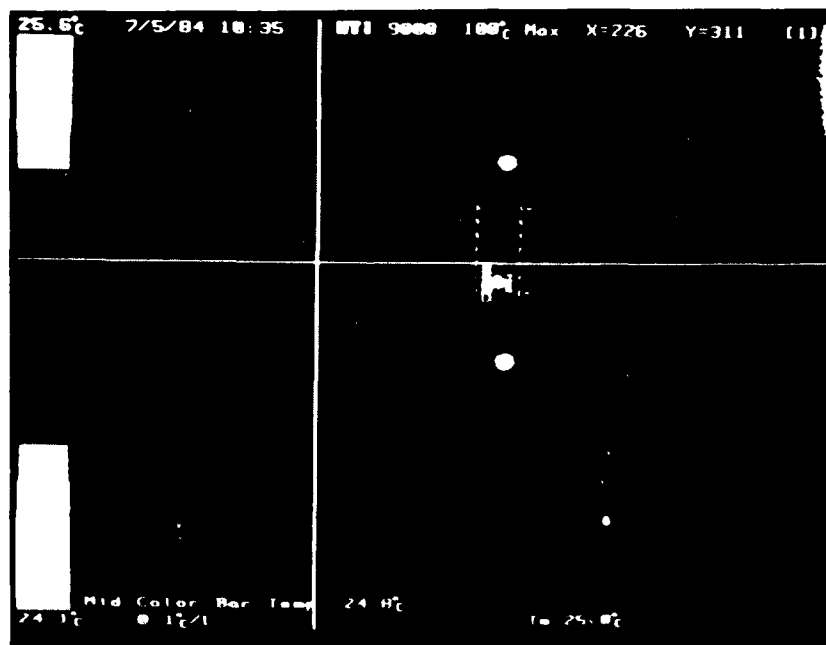
Figure 3 Typical delta mode, "complete failure"

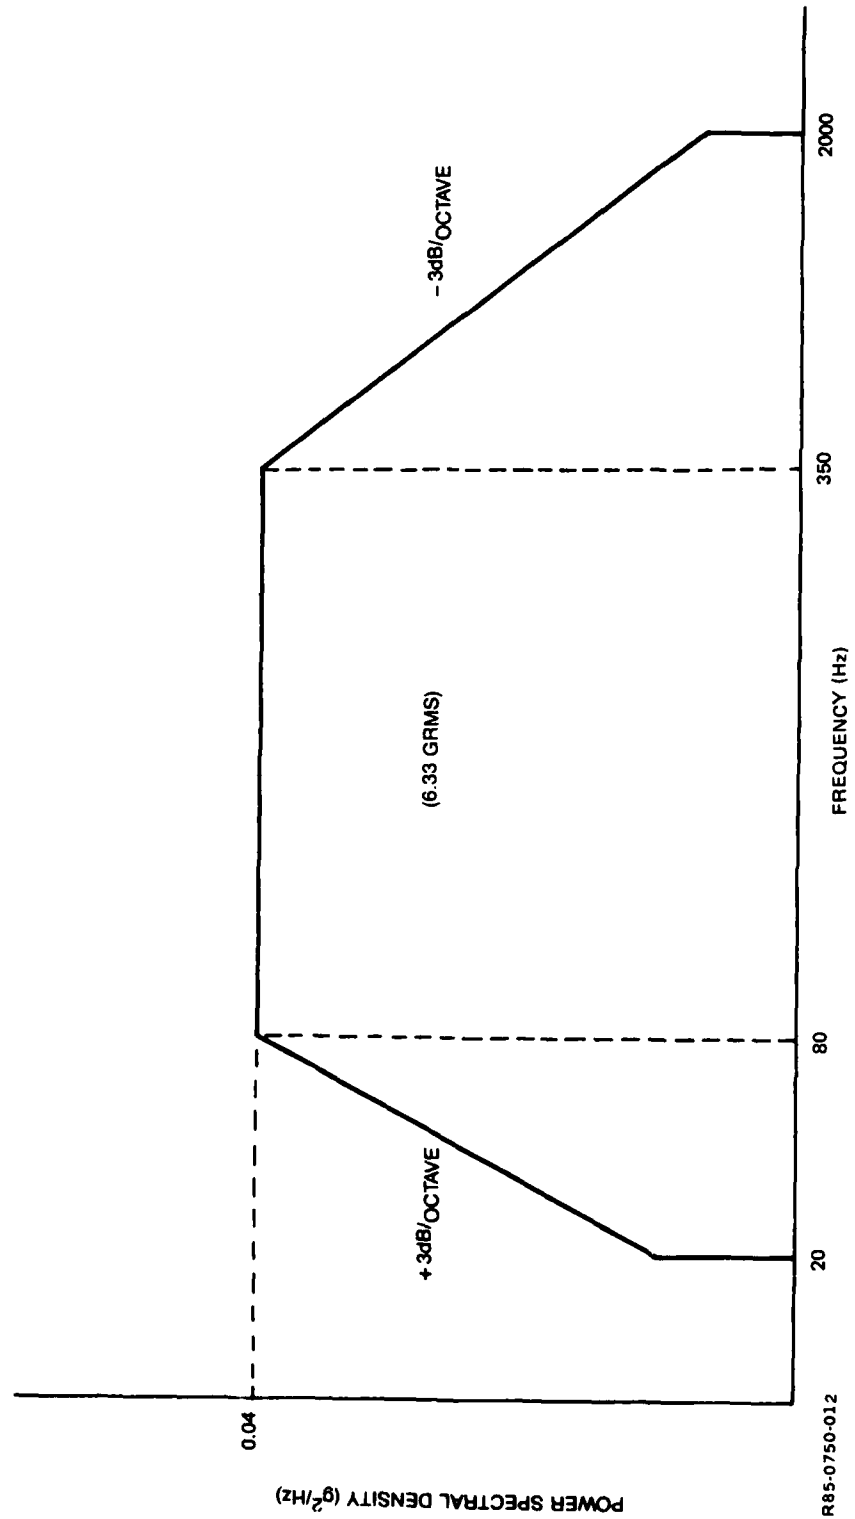
Figure 12 Random vibration spectrum

Upon completion of the Phase II static ambient tasks, the same test articles were examined under dynamic conditions of random vibration (Figure 12) and thermal cycling (Figure 13), still using the failure analog approach. One of the typical production boards of Phase II was designated as the reference board.

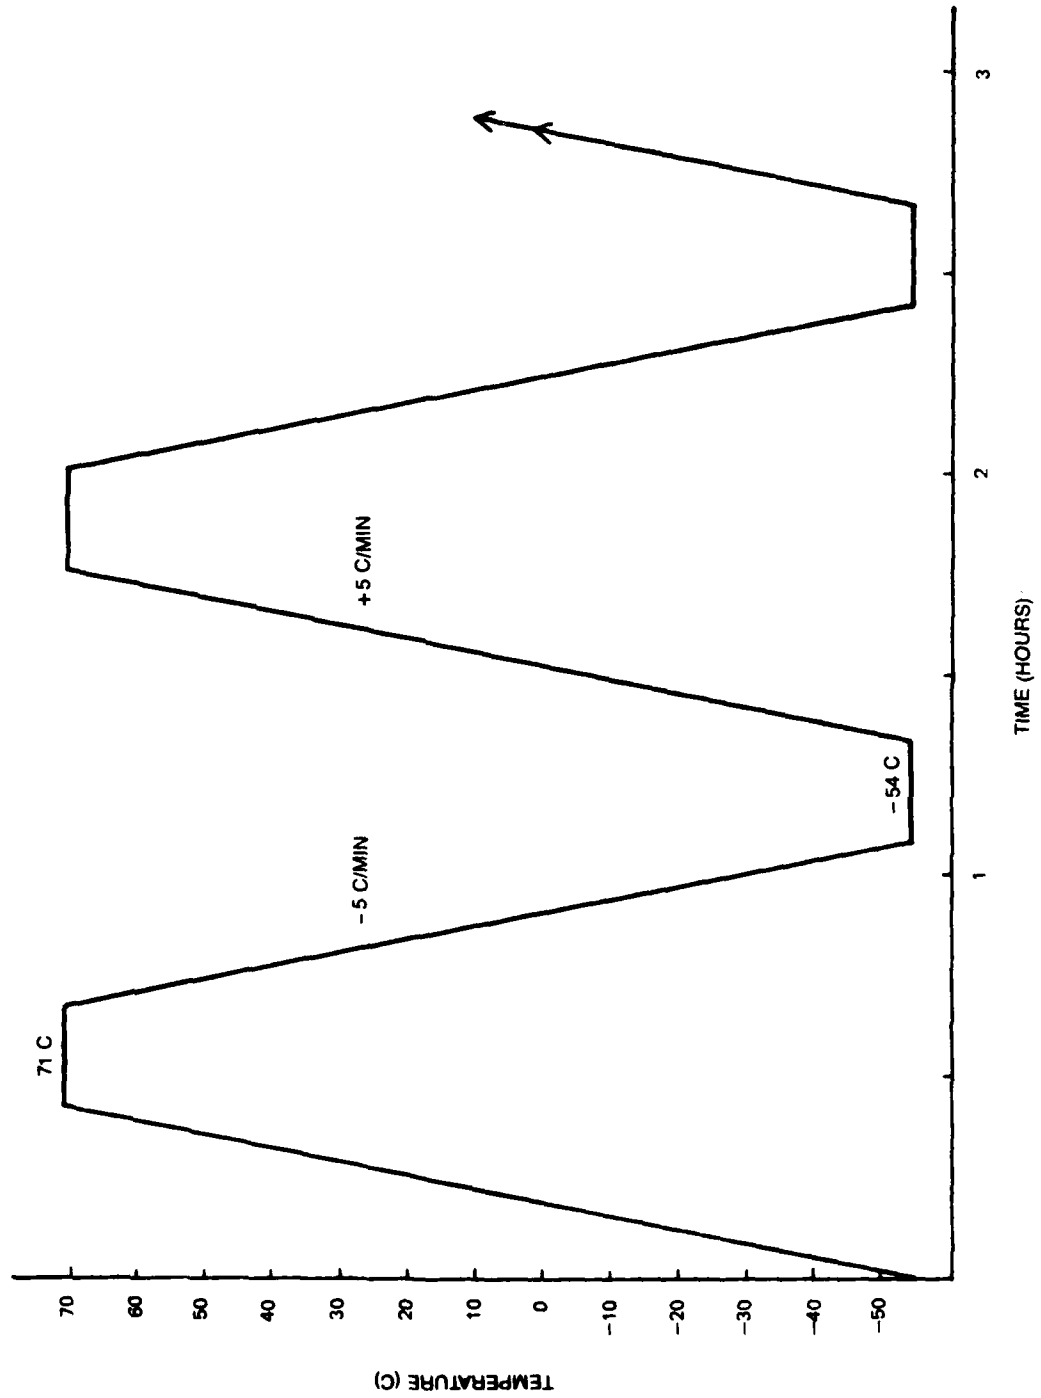
Figure 13 Rapid thermal cycle chamber profile

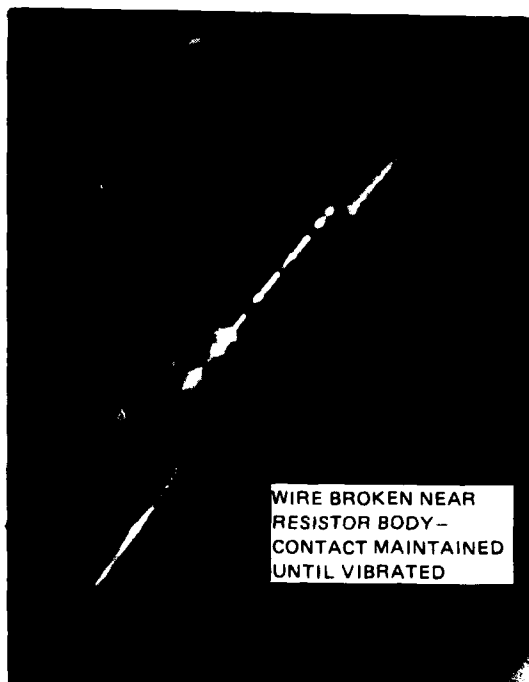
Figure 19 External lead wire damage (10X) component

- No solder connections (Figure 17)
- Poor solder connections (Figure 18)
- Component external lead wire damage (Figure 19 and 20)
- Component internal wire bond defect (Figure 21)
- PCB trace damage (Figure 22).

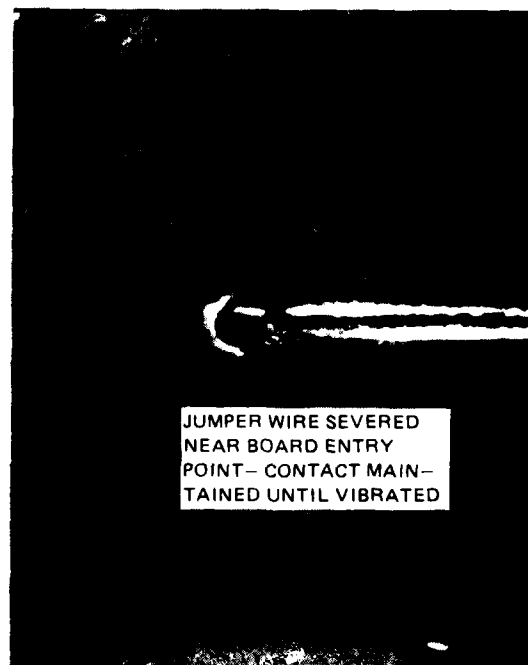
Figure 20 External lead wire damage (10X) PCB

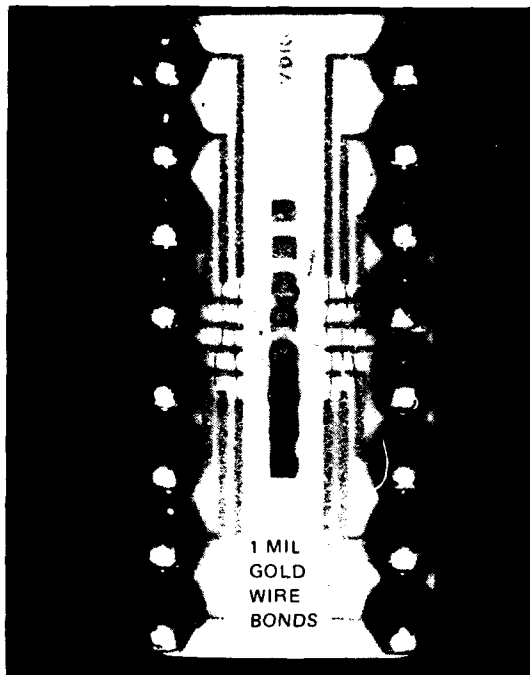
Figure 21 Internal wire bond defects (5X)

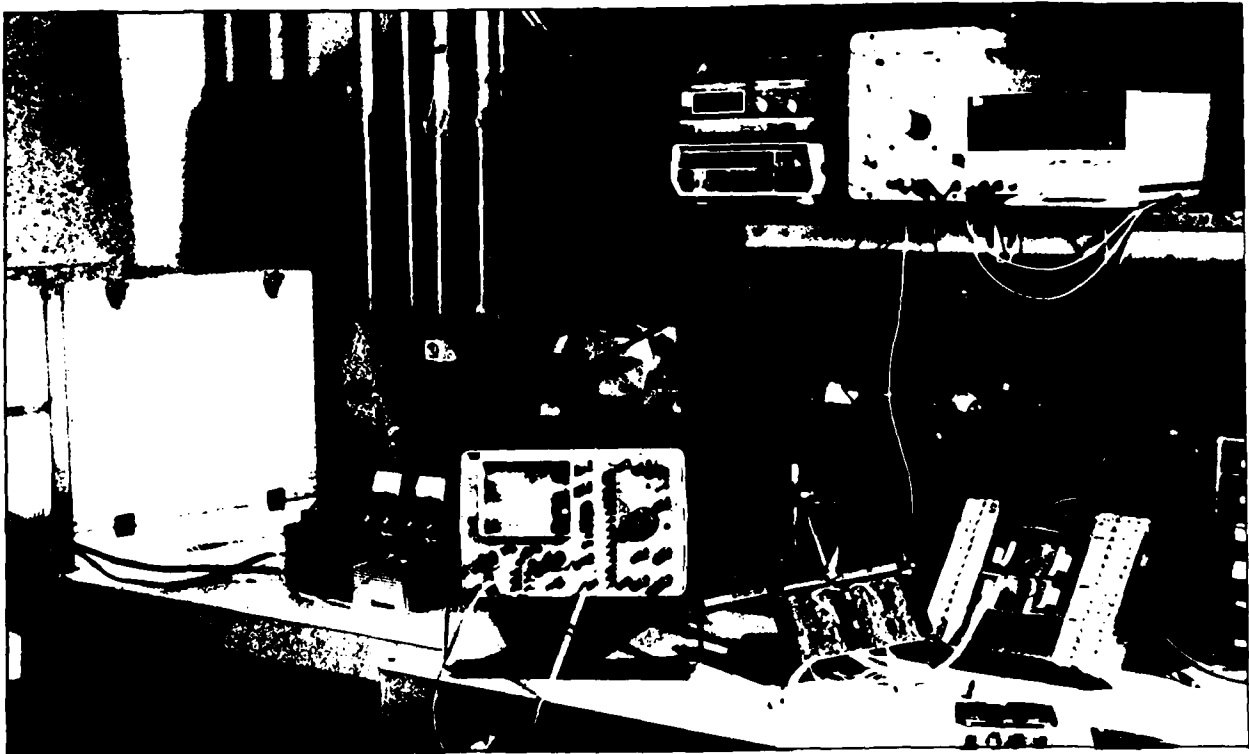
Figure 23 Component test holding fixtures and test equipment

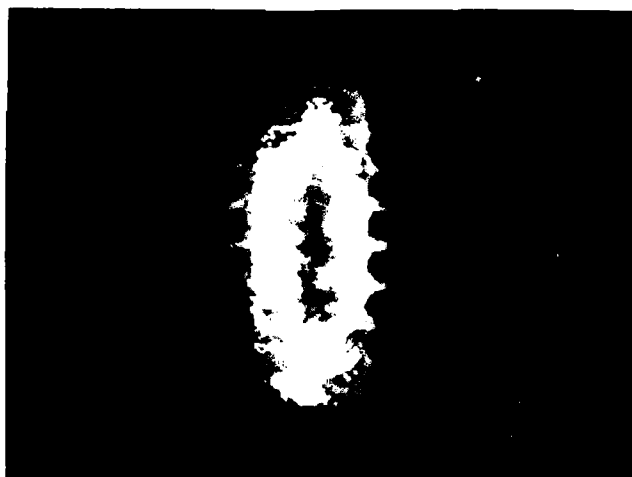
However, the effects of heat spread within a device such as a resistor network were found to be significant. Figure 36 shows a software-magnified thermal image of a resistor network having eight individual 500 Ohm resistors on a common substrate. The total package power dissipation was 0.400 W (8.0×0.05 W).

Figure 36 Software magnified thermal image of resistor network

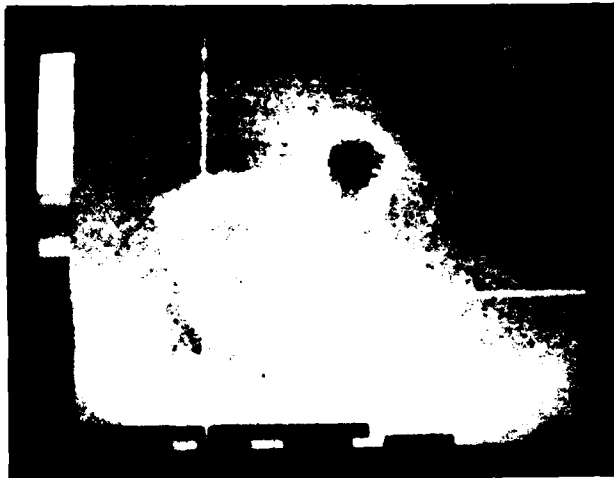
Figures 37 and 38 depict unmagnified delta runs of the resistor network at reduced power levels. Figure 37a is the result of completely turning off one resistor located at the end of the package (all others left on), while Figure 37b shows the result of turning off one in the center of the package. Both conditions represent a decrease of 0.05 W in total package dissipation, but the end resistor is much more apparent. This was considered to be due to the heat spread from adjacent resistor elements.

a. End resistor turned off, others power on

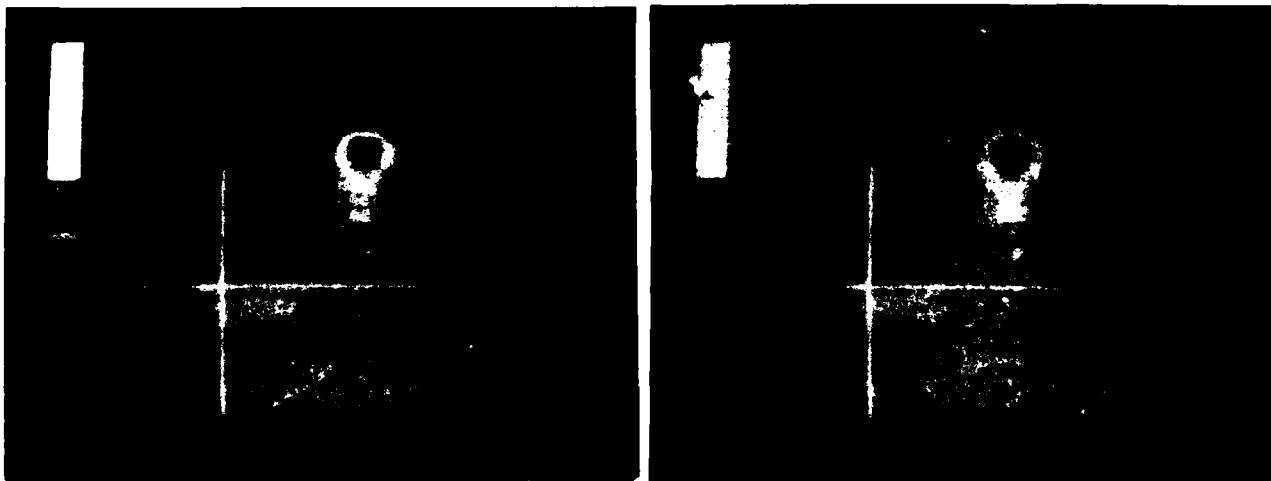
The test fixture holding the components was in a fixed position relative to the FOV of the imager. However, it was determined that a sufficient amount of motion of the Test Article (TA) within the zero insertion force socket or the bend point of resistor leads could introduce a positional error between the standard and subsequently compared items. Figure 39 shows two different samples of a resistor

Figure 39 Positional variations affect thermal signature

network package, both with one resistor at the top end of the package turned off (reference image had it on). Electrical measurements showed less than a 0.3 mW difference and therefore no signature difference should be visually detectable. It was considered that this problem would not be as great when comparing PCB's since the individual component locations for a given position on a board are rather precisely fixed through photographic processes. The overall position of the board itself within an electrical connector is variable but it was considered that a means of repetitive location could be established and that overall mispositioning could be readily identified.

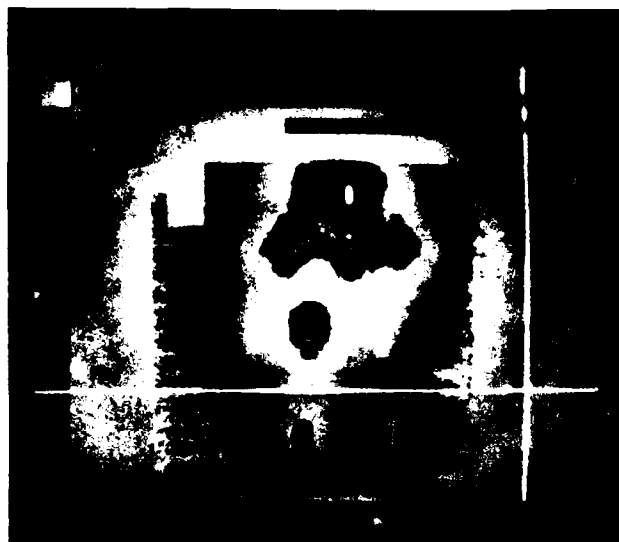
Figure 41b presents the unpowered delta image of the same assembly after power had been removed for a period of ten minutes (note that the reference image circuit operating condition information is retained in this and subsequent photographs). All of the components that had previously been operating at power levels equal to or greater than approximately 15 mW can now be seen to be displayed as being cooler.

a. Reference image - power on for 3 min.

Figure 41 Reference and delta image comparisons

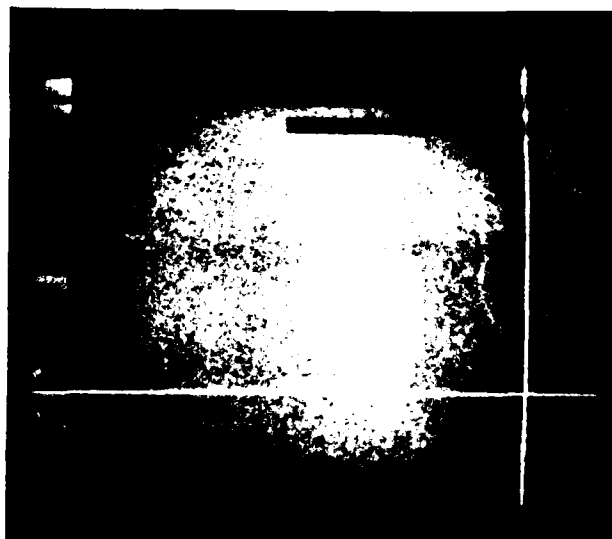
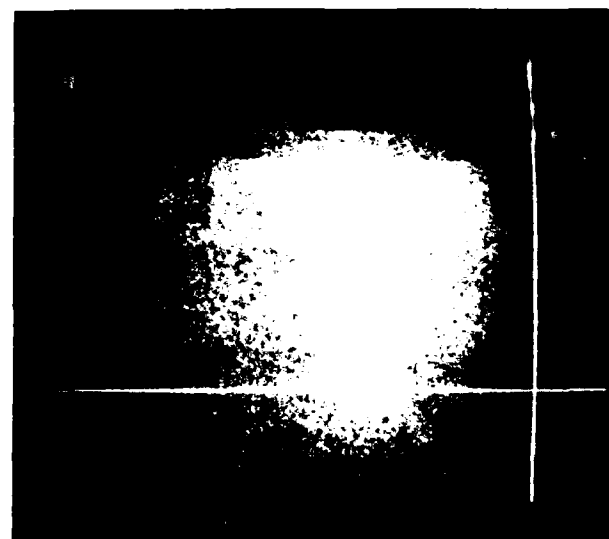
a. Delta image - 3 min. power on (no failure)

b. Delta image - 3 min. power on (no failure repeat)

Figure 42 PCB level repeatability experiments

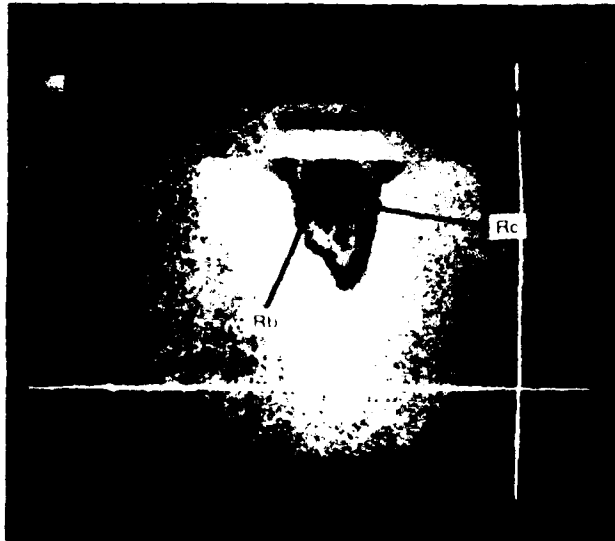
Still comparing a particular assembly against itself, various failure analogs were introduced in order to determine if the Phase I observations relative to TOD, heat spread effects and defect growth feasibility were applicable at the PCB level. A typical experimental sequence is shown in Figure 43.

a. Delta image - complete functional failure of transistor Q1 circuit
Rb = base limiting resistor
Rc = collector load resistor

b. Delta image - partial failure of Q1 circuit
Rb = -34 mW

c. Delta image
Rb \cong -32 mW
Rc not visible

d. Delta image
Rb \cong -27 mW

Figure 43 PCB level tracing experiments - defect analogs (sheet 1 of 3)

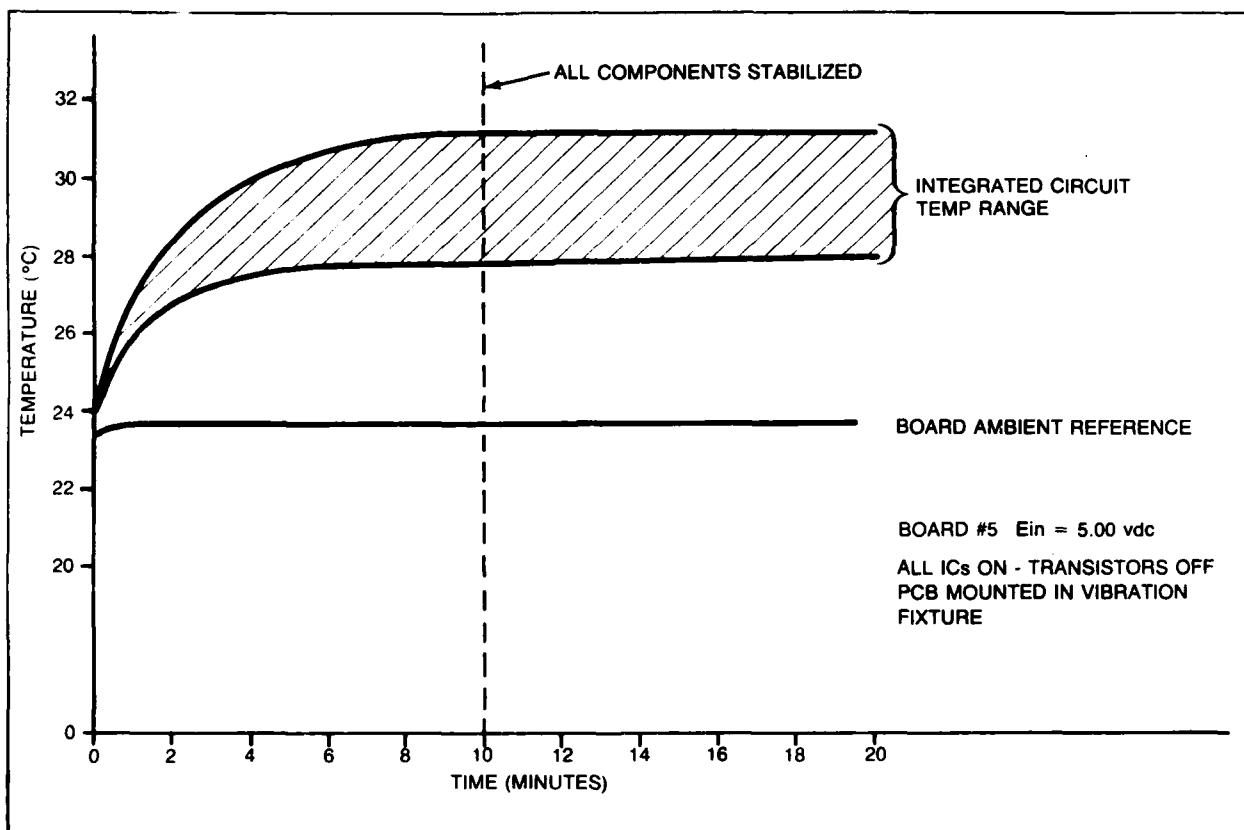
Using PCB no. 5 as the "golden board", both a thermally stabilized (ten minute power-on) static reference and a dynamic reference representing an additional five minutes of power-on time with vibration (a total of 15 minutes of power-on time, the last five minutes includes vibration) were made and recorded on discs. The series of delta runs, noted in Table 1 were then made by recalling this data and using it as a reference. In each case the PCB under test was initially examined against the PCB no. 5 static reference, thereby establishing its pre-vibration operational status. It was then continuously examined (in the delta mode against the dynamic

Figure 52 PCB temperature/time history

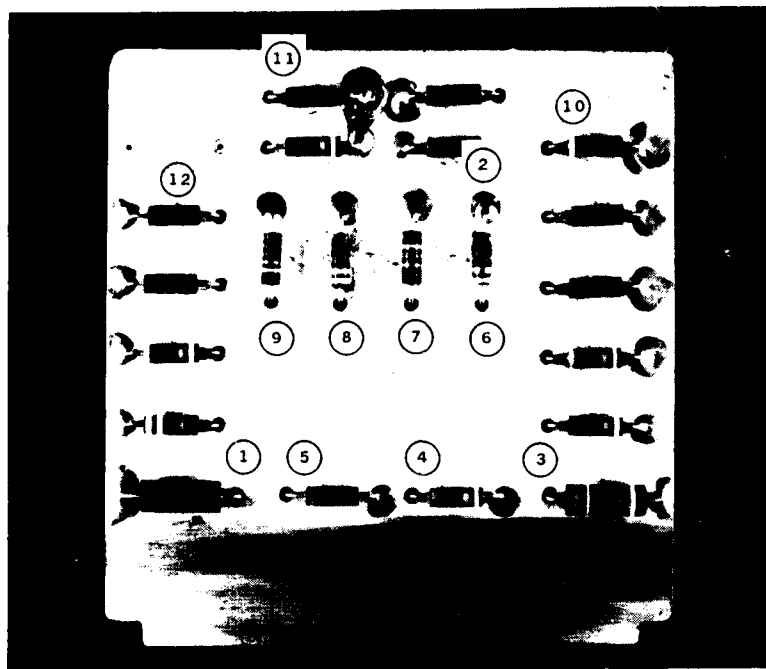
The primary test article for these tests was a PCB having 21 resistors mounted to it (Figures 66 and 67). Verification of the revised test set-up was accomplished with this test article. Subsequent tests utilized this same test article with the ability to insert failure analogs at twelve discrete locations. As these experiments progressed, it was postulated that a modified form of continuous thermographic monitoring could be accomplished during the dynamic periods of the thermal cycle above 0.0 C. This theory was proven by the insertion of both permanent and short term intermittent failure analogs.

Figure 66 Temperature cycling test resistor board - component side view

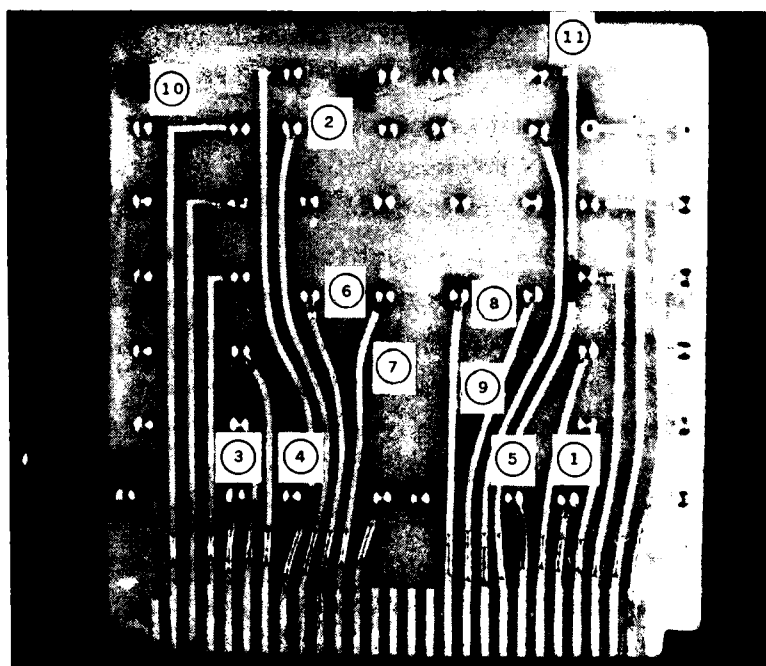
Figure 67 Temperature cycling test resistor board - wiring side view

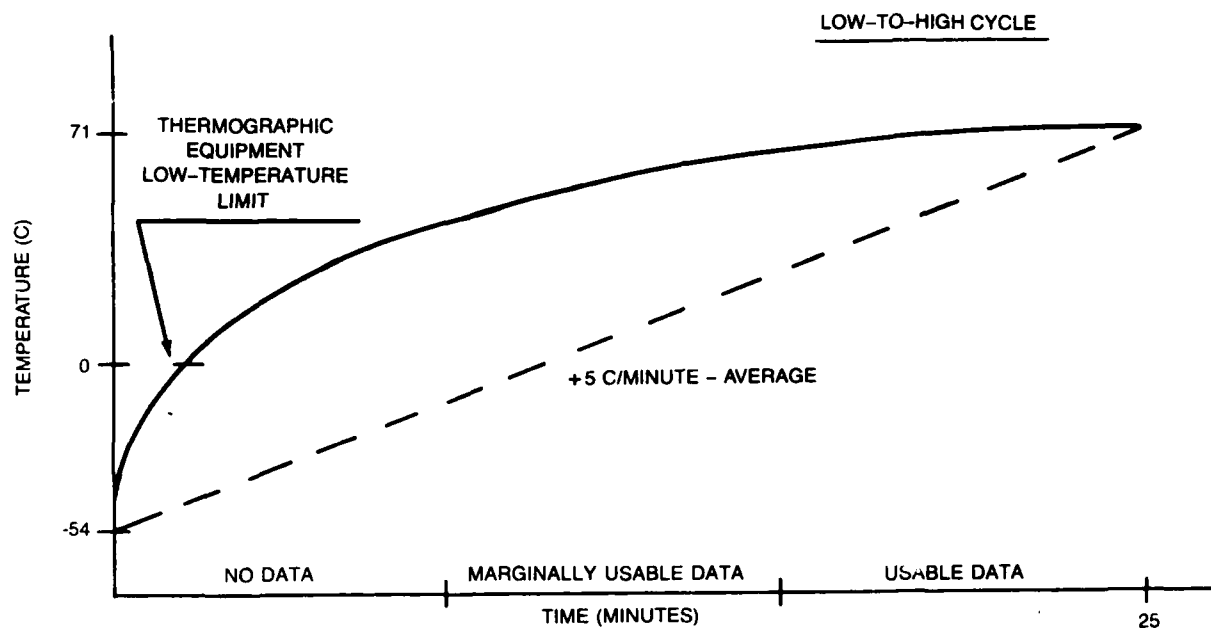
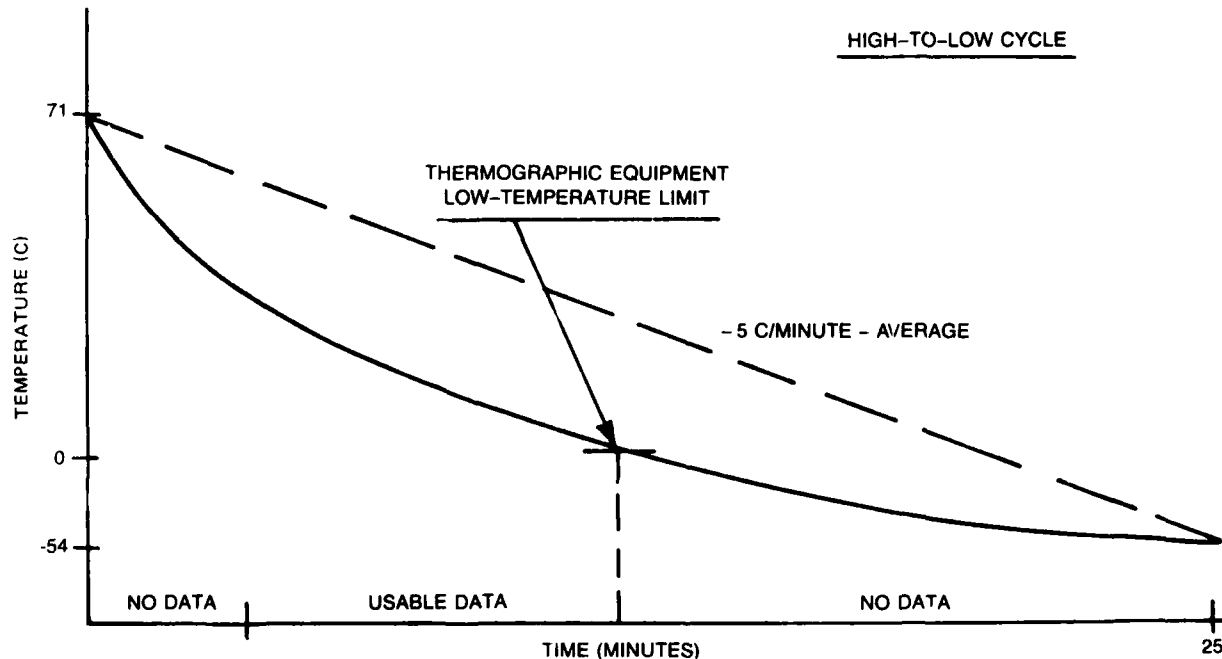
R85-0750-072

The available viewing time is a function of the instantaneous rate of change of the thermal chamber. Since a minimum of 20 seconds was necessary to allow a defect at the TOD to be visually detectable, and since changes in ambient temperature in excess of 2.0 C confounded the interpretation of the display, chamber rates of change greater 6.0 C/minute precluded the use of this technique (Figure 68).

Figure 68 Typical chamber cycle
